TECHNICAL NOTE 2996

APPRAISAL OF HAZARDS TO HUMAN SURVIVAL IN AIRPLANE CRASH FIRES

By Gerard J. Pesman

Lewis Flight Propulsion Laboratory
Cleveland, Ohio

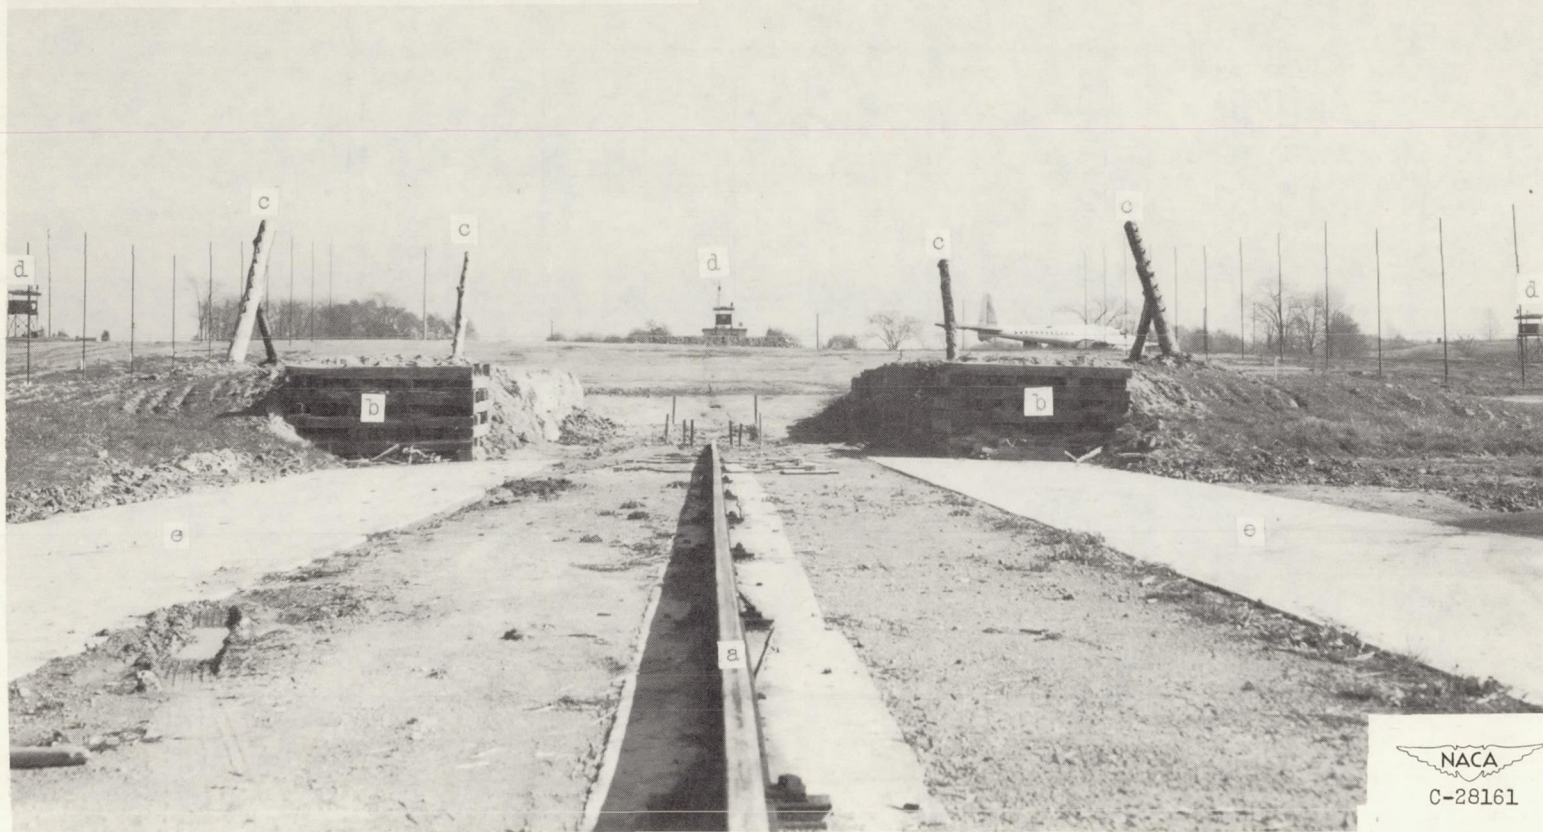
NACA
C-28161

- a Guide rail
- b Timber-and-dirt barrier to damage propellers and landing gear
- c Spike-studded poles to tear open fuel tanks
- d Stands for motion-picture cameras
- e Paved runways for main landing gear wheels

Figure 1. - Crash site showing end of guide rail, propeller and wheel barriers, fuel-tank pole barriers, and camera stations.

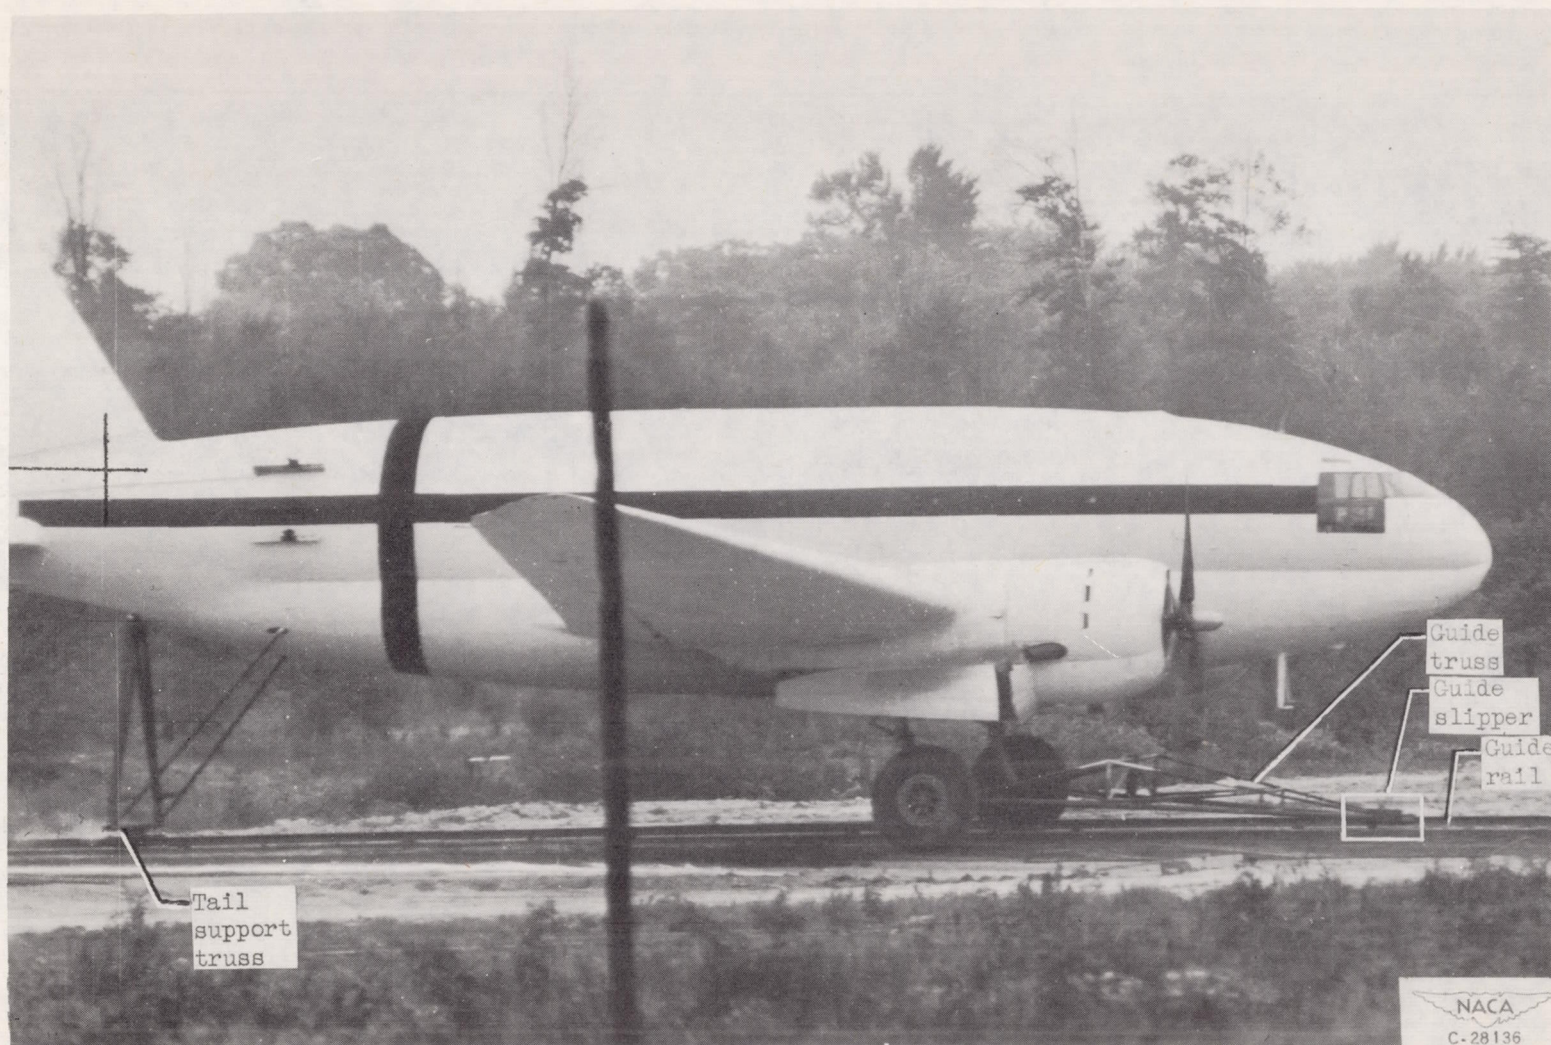
Figure 2. - Airplane with conventional landing gear traveling along guide rail showing guide slipper, guide truss attached to main landing gear, and tail support truss that slides along top of guide rail.

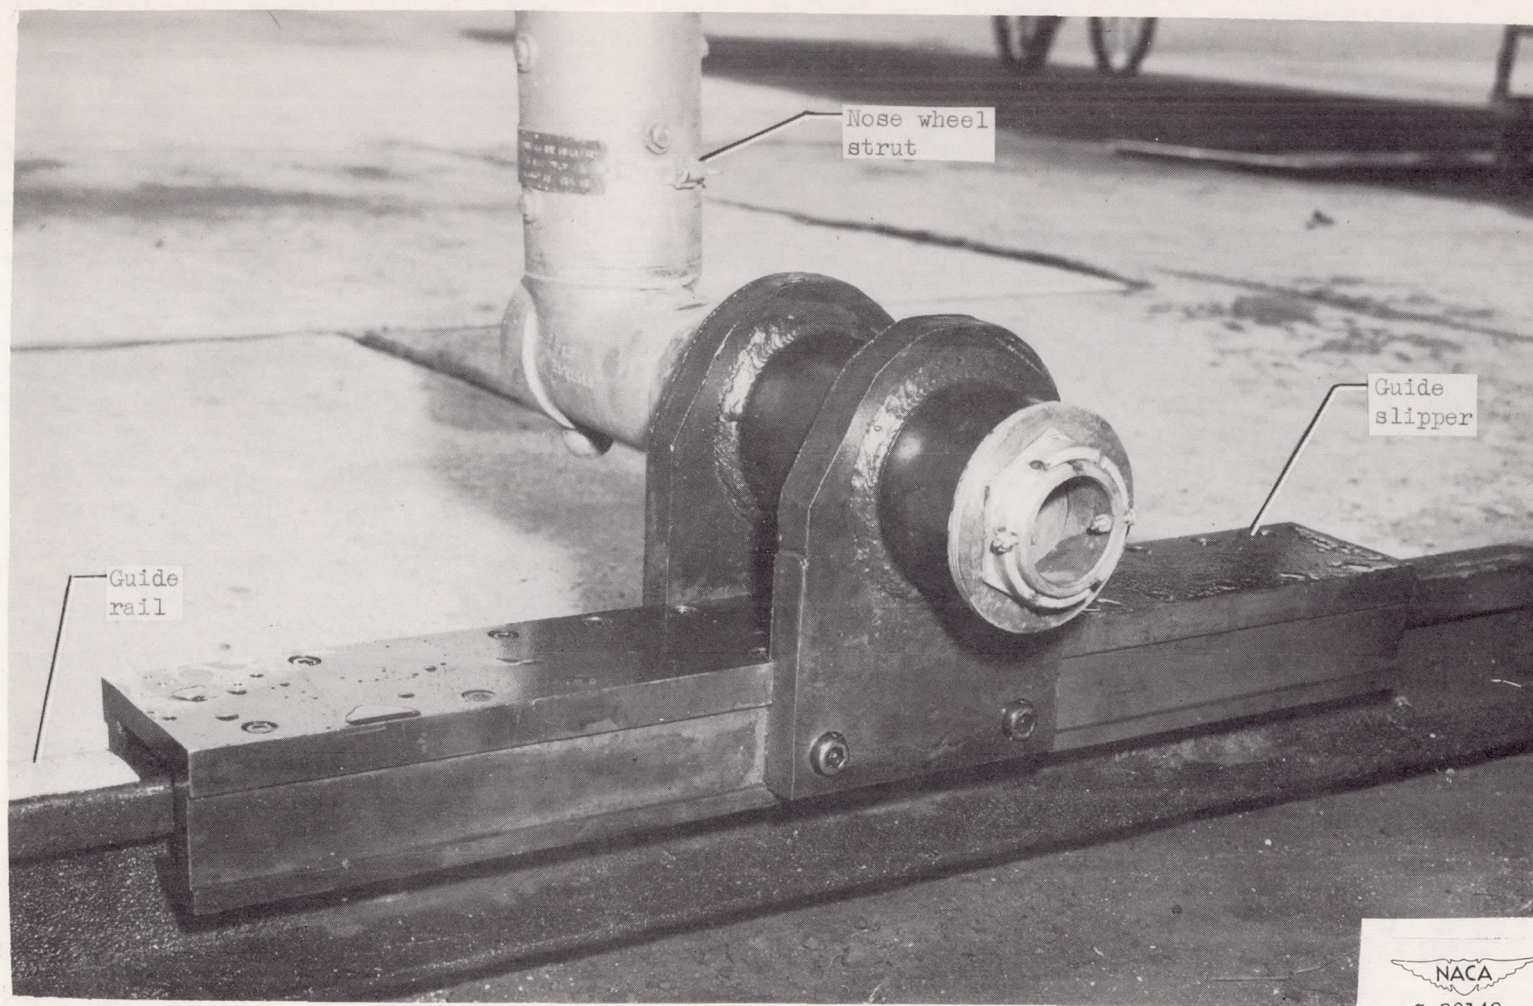
NACA
C-28142

Figure 3. - Airplane with tricycle landing gear traveling along crash strip showing guide slipper attached to strut and replacing nose wheel.

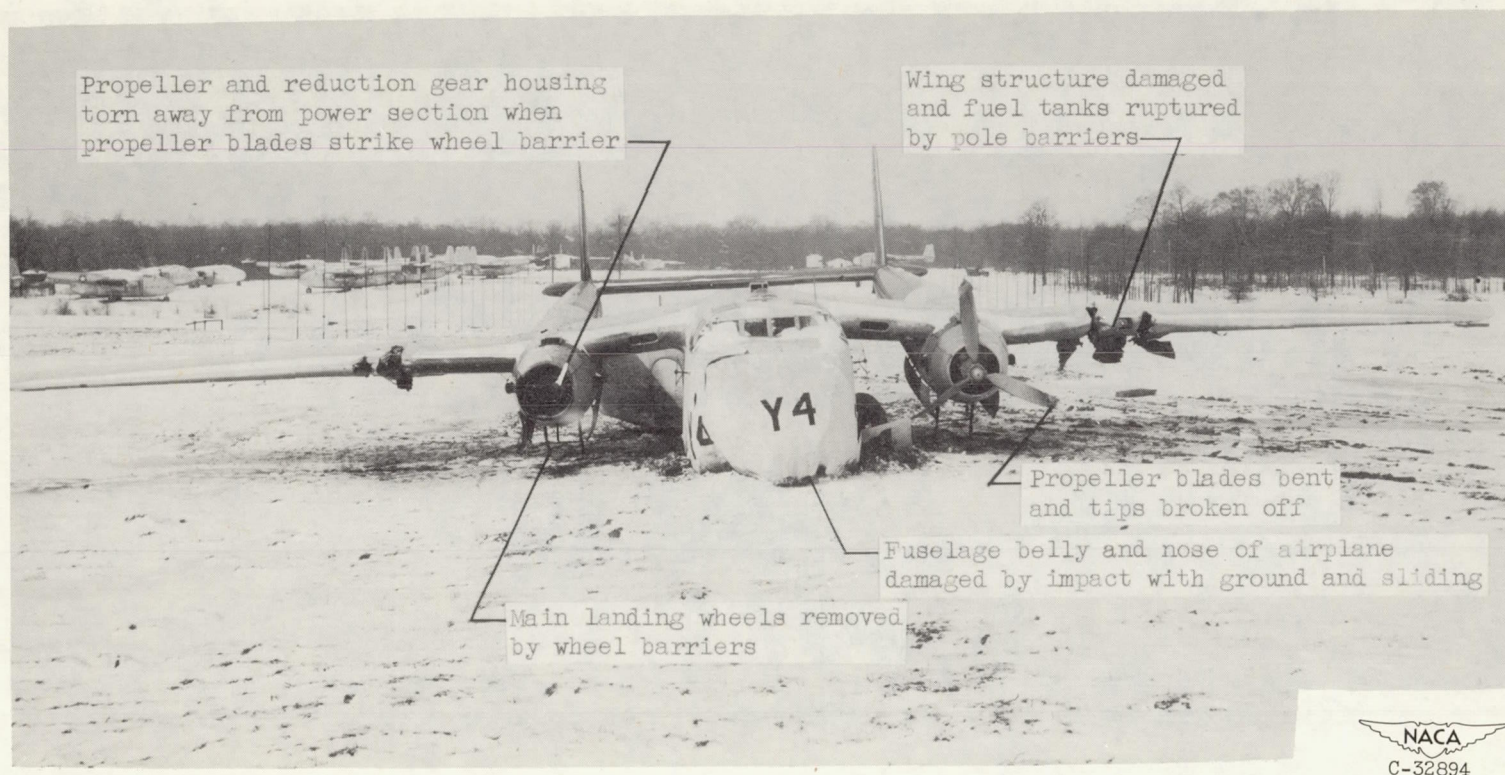
Figure 5. - Damage inflicted to airplane and engines by wheel barriers, fuel tank barriers, and contact with ground.

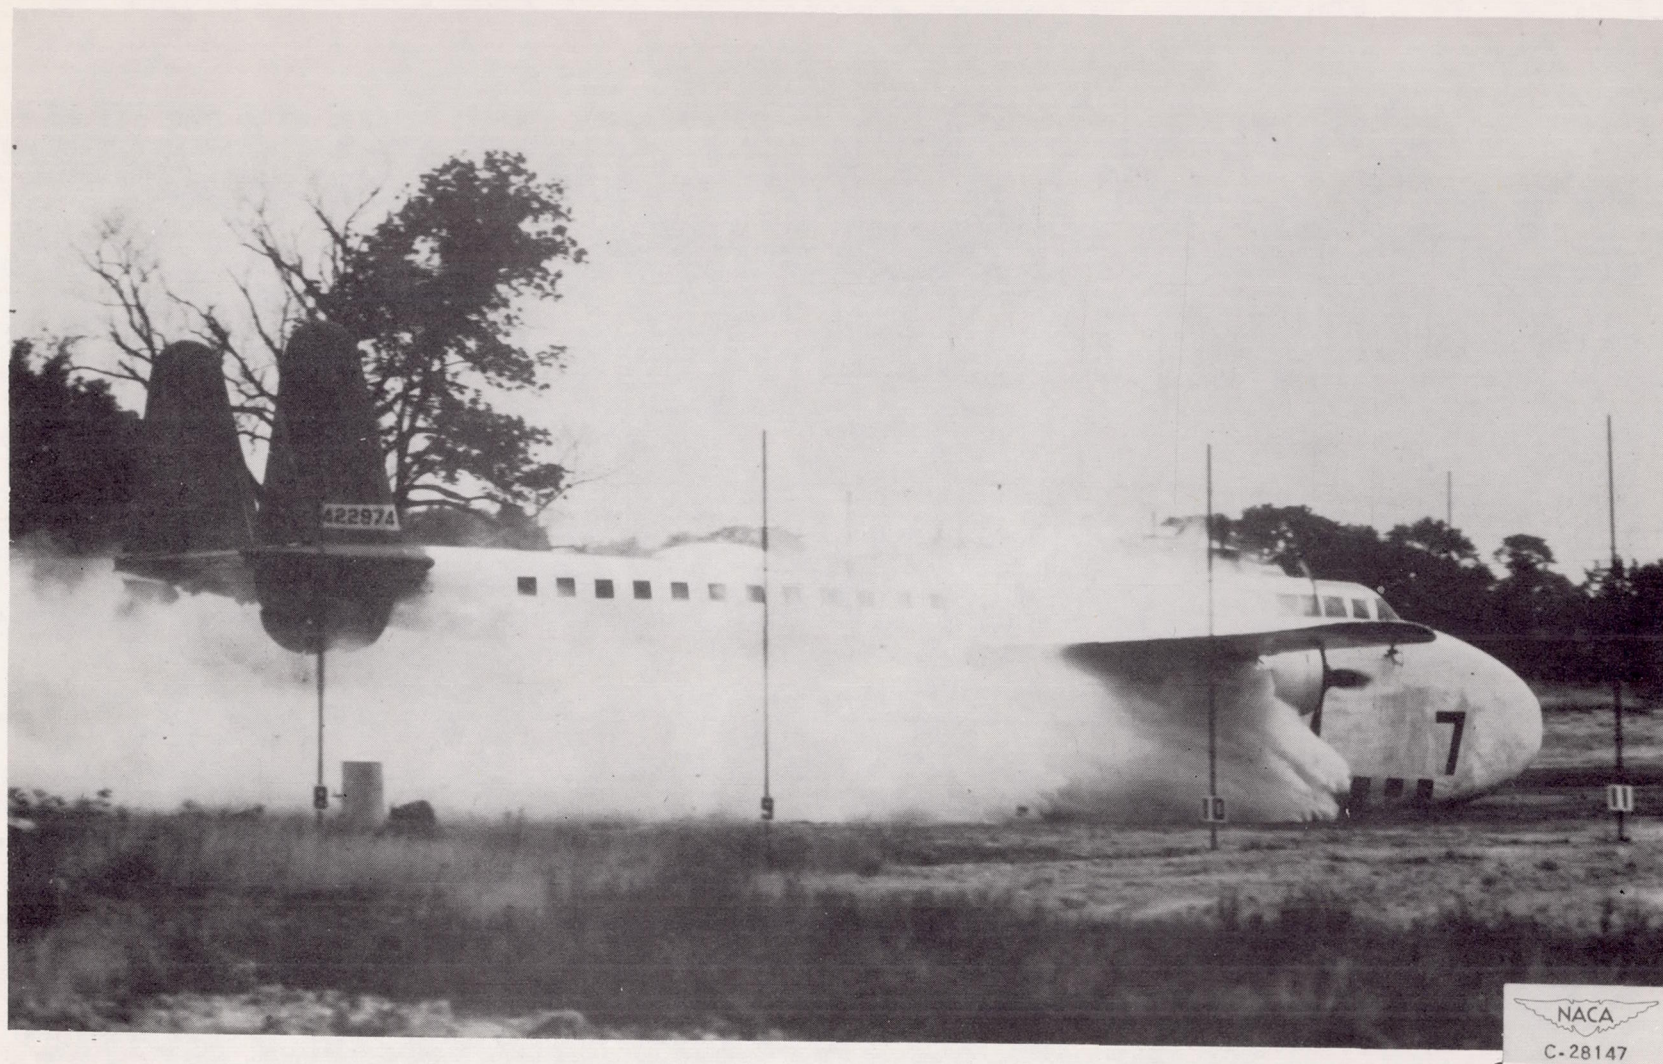
Figure 9. - Typical fuel mist formed when either gasoline or low volatility fuel tanks are ruptured while airplane is in motion. Fuel mist appears as white cloud around and behind wing surfaces. No fire existed at time this photograph was taken.

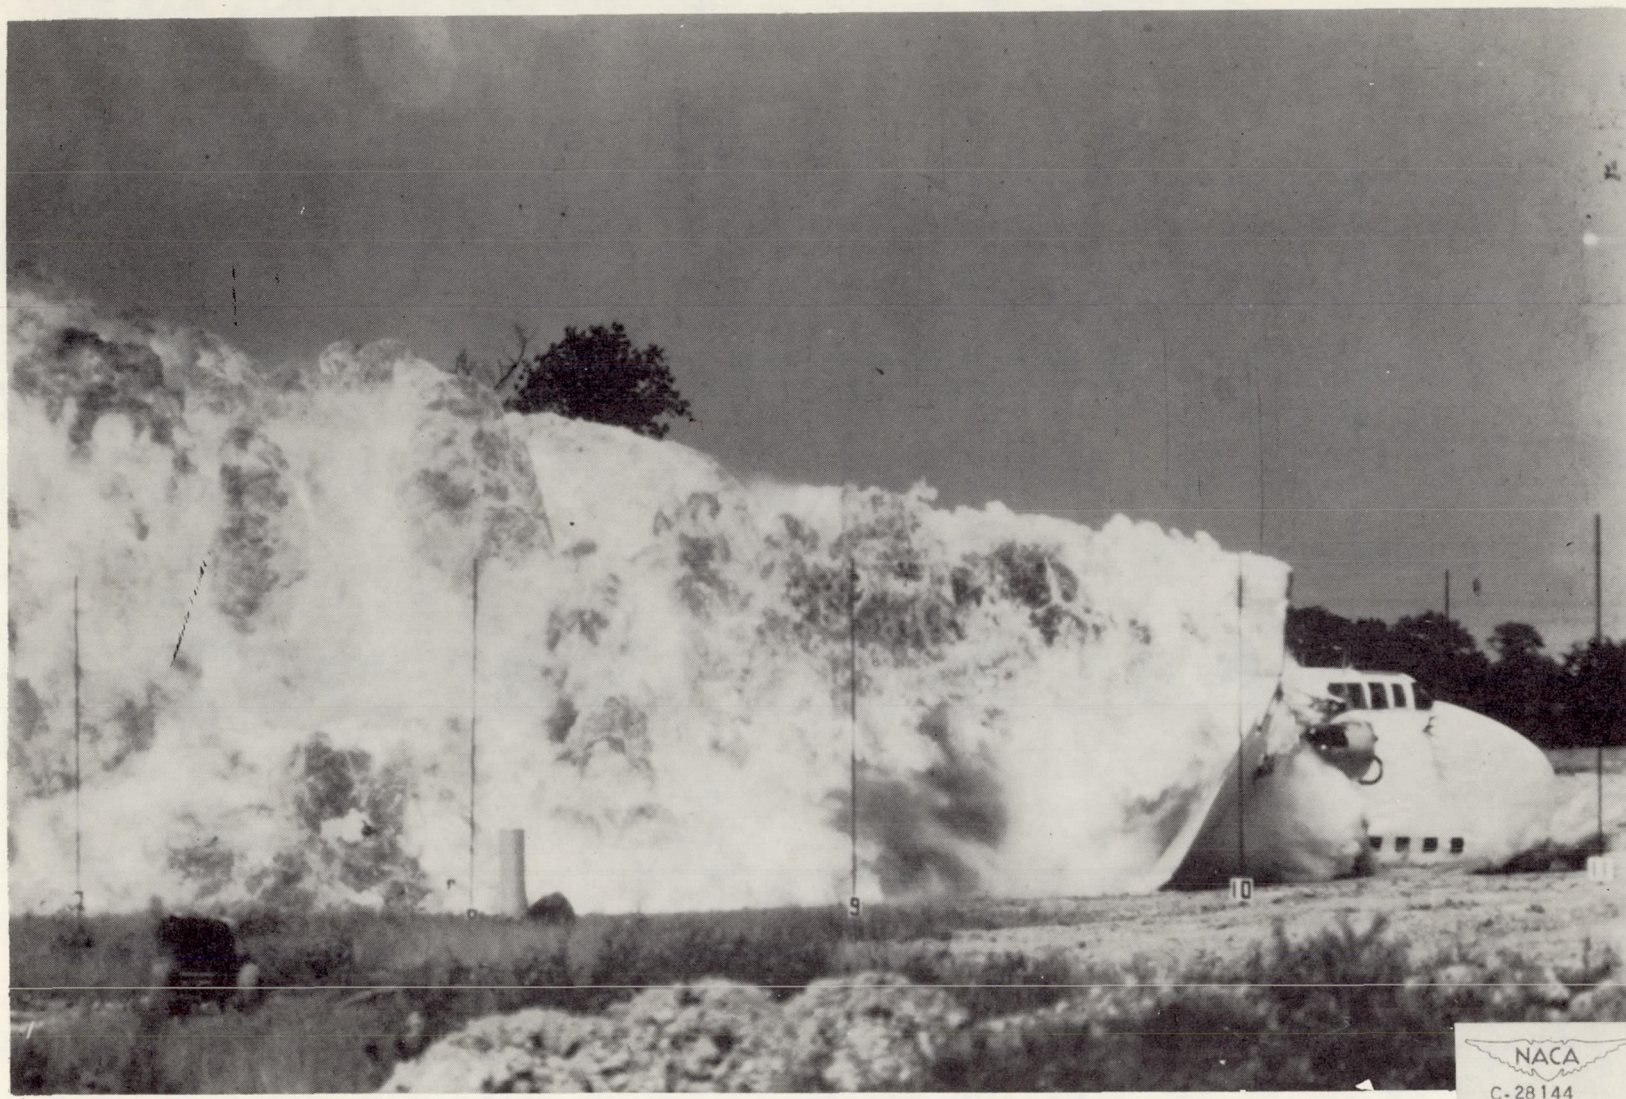
Figure 10. - Fire resulting from ignition of cloud of gasoline mist.

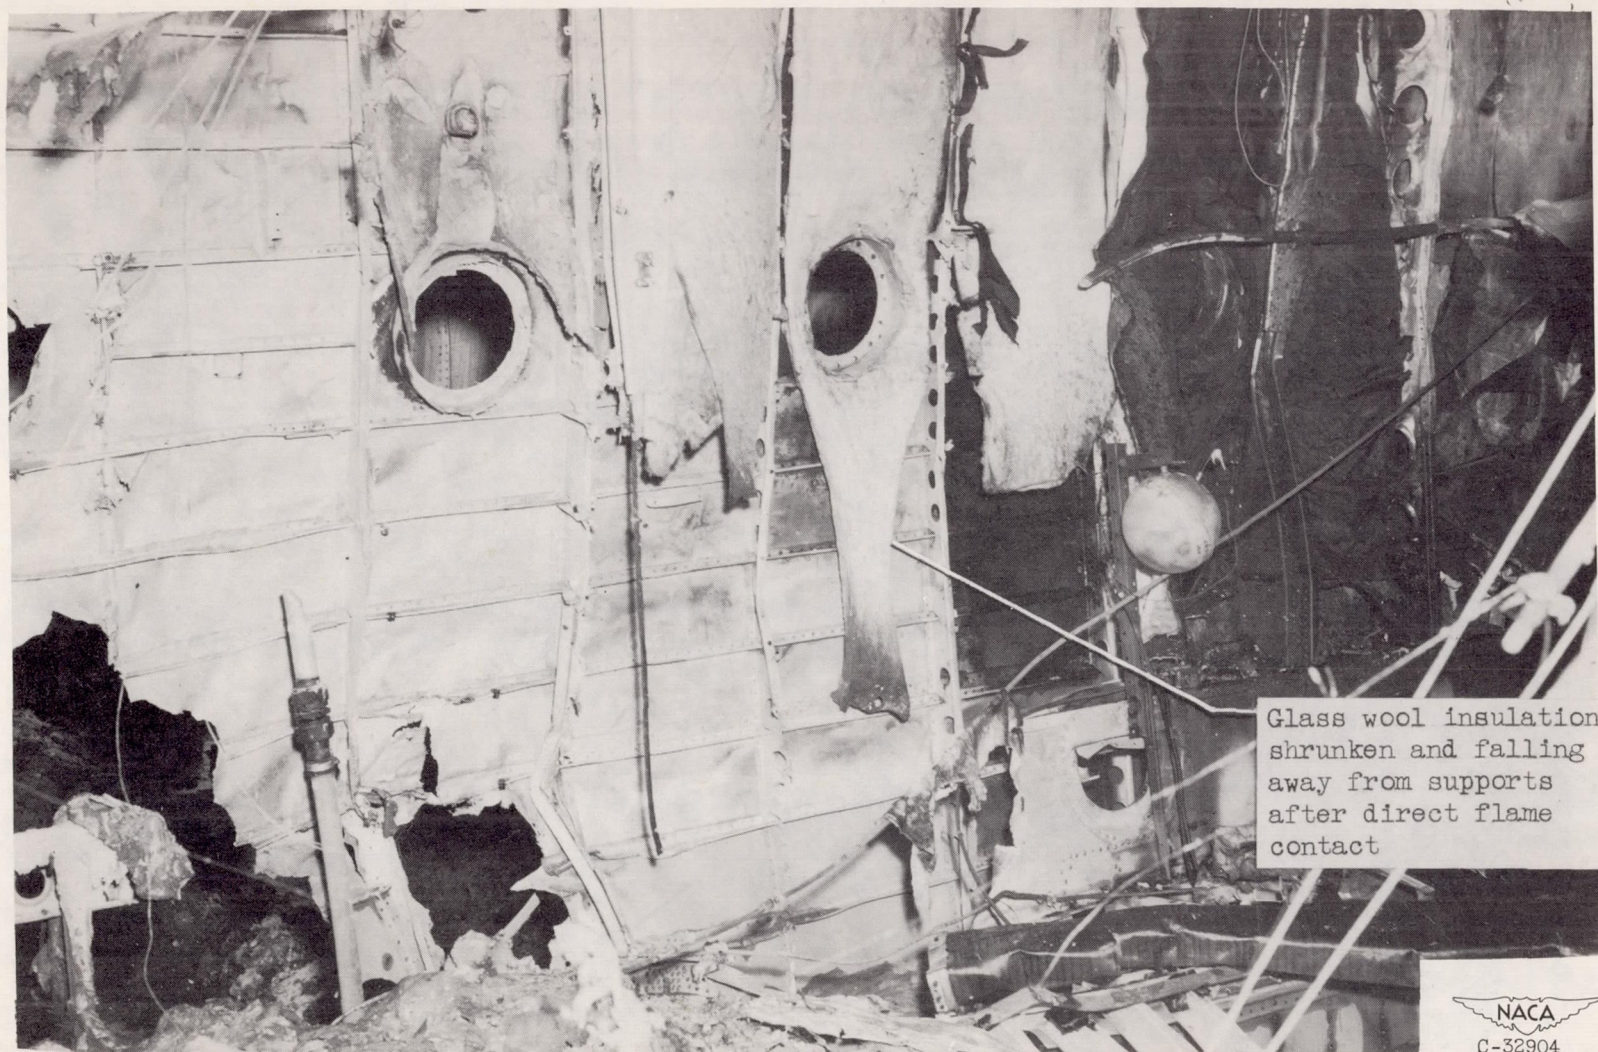
As a result of these temperature conditions the thermal escape time for the insulated enclosure was about 8 minutes; whereas for the uninsulated enclosure, the escape time was $8\frac{1}{2}$ minutes. These escape times show that the glass wool insulation presently used in commercial transport aircraft will not increase the escape time appreciably and may decrease the available time slightly. The glass wool insulation also offers little obstruction to the passage of flame and gases because it tends to shrink and fall away from its supports when exposed to direct flame contact. The shrinkage resulting from such flame contact is shown by figure 17.

Glass wool insulation
shrunk and falling
away from supports
after direct flame
contact

Figure 17. - Effect of direct flame contact upon some glass-wool types of thermal and sound insulation.

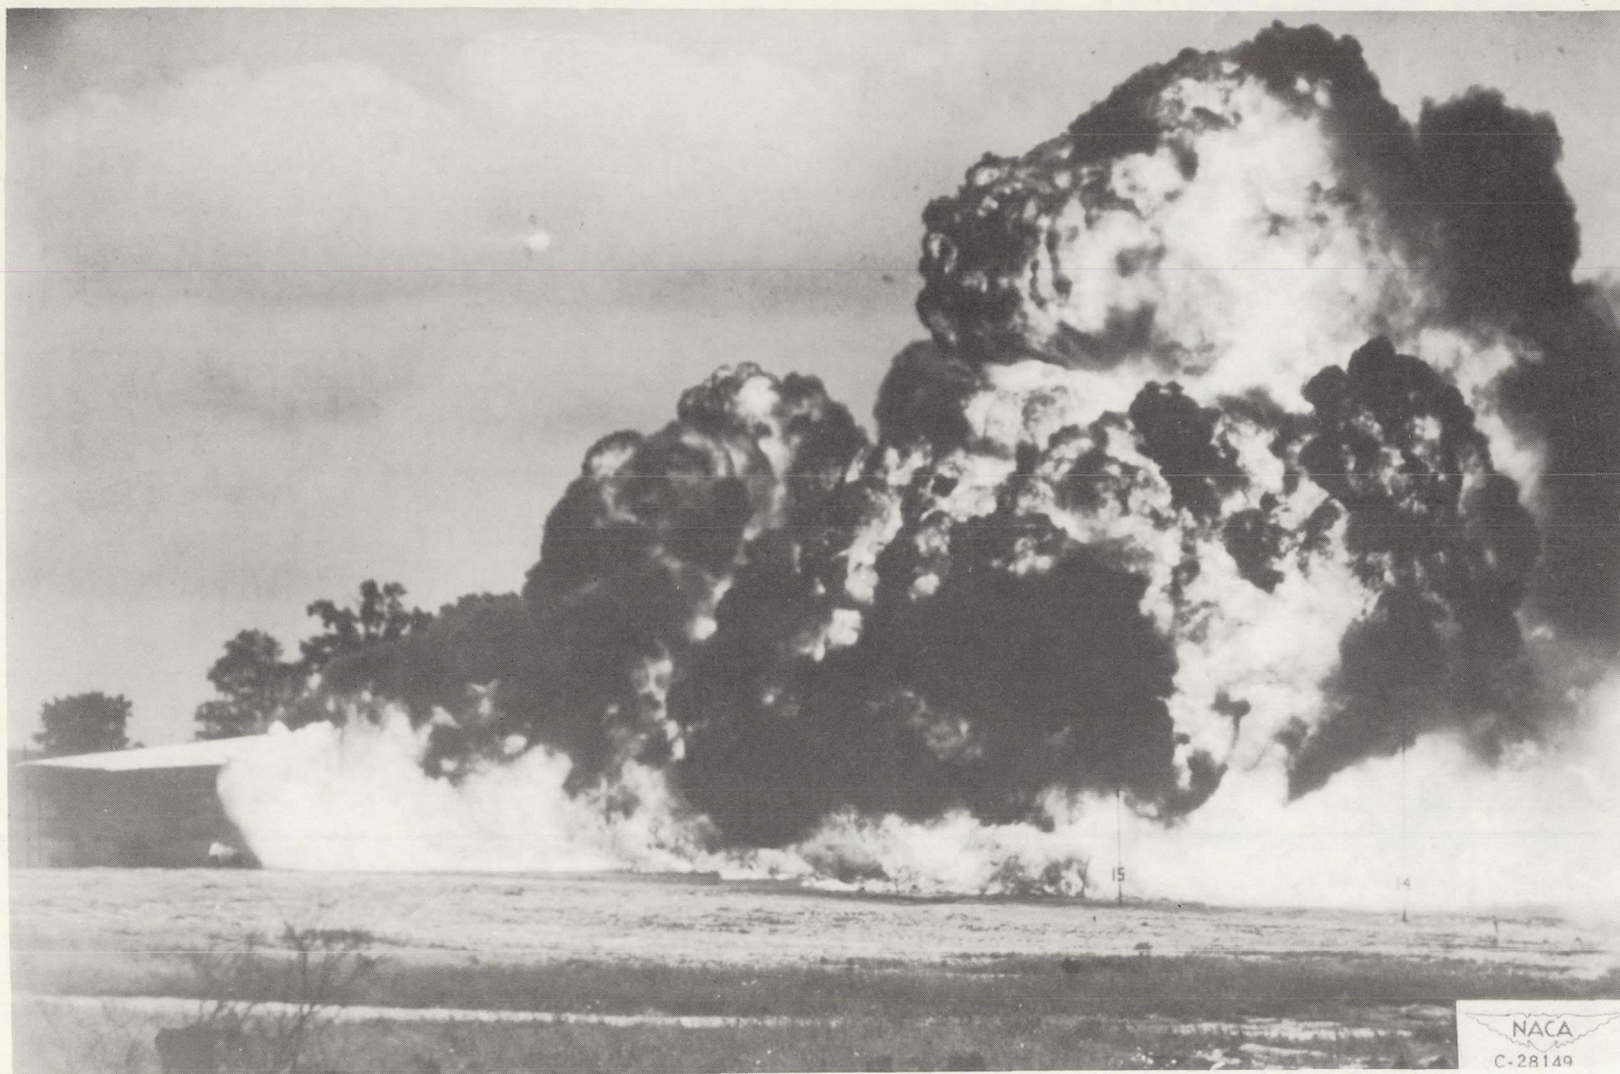
Figure 18. - Fire resulting from ignition of cloud of low-volatility fuel mist.

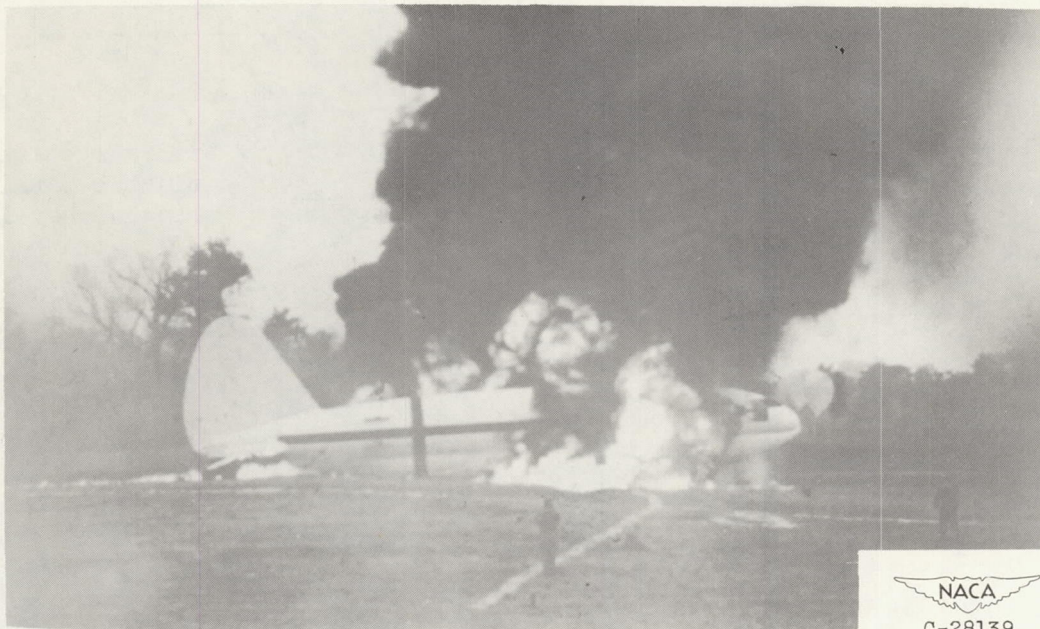
a) Escape avenue to right rear of airplane open approximately 30 seconds after impact and after fuel mist flash fire had burned away; wind from right rear; crash 1.

(b) Escape avenue to left front; wind from left rear quarter, variable at 0 to 5 miles per hour; crash 3.

Figure 24. - Escape avenues.

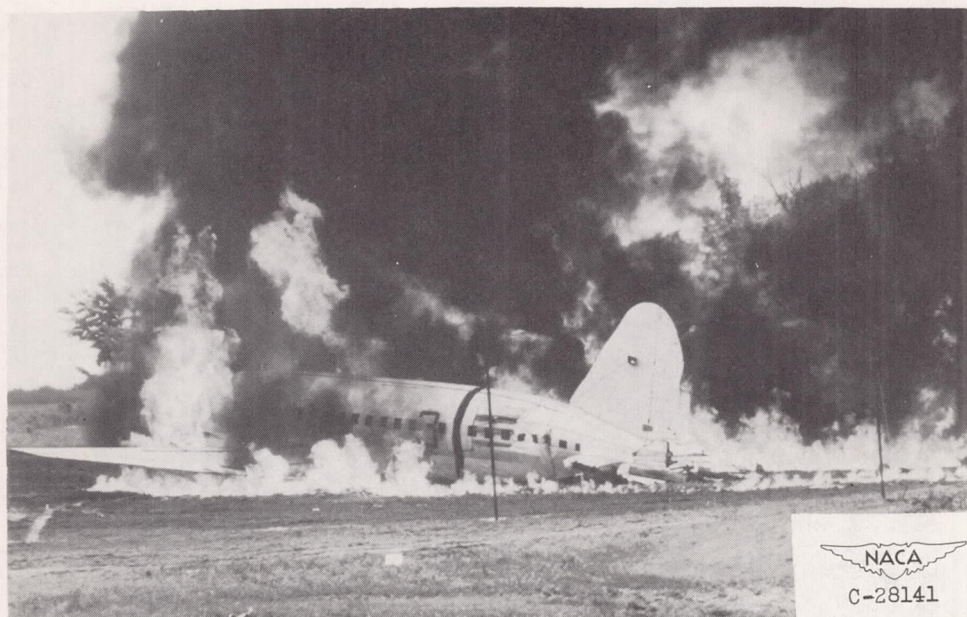
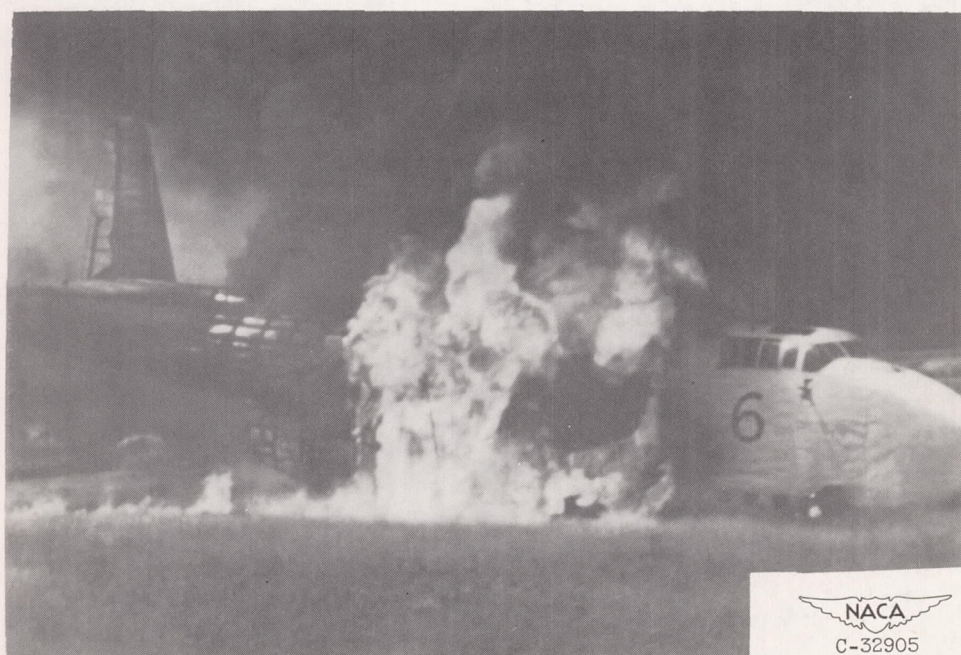
(c) Escape avenue to left rear after major part of spilled fuel had burned away; wind from left rear, 0 to 5 miles per hour; crash 3.

(d) Escape avenue to right front; wind from right rear, 13 to 16 miles per hour; crash 6.

(e) Escape avenue to right rear after fuel mist fire burned away; wind from right rear, 10 to 15 miles per hour; crash 7.

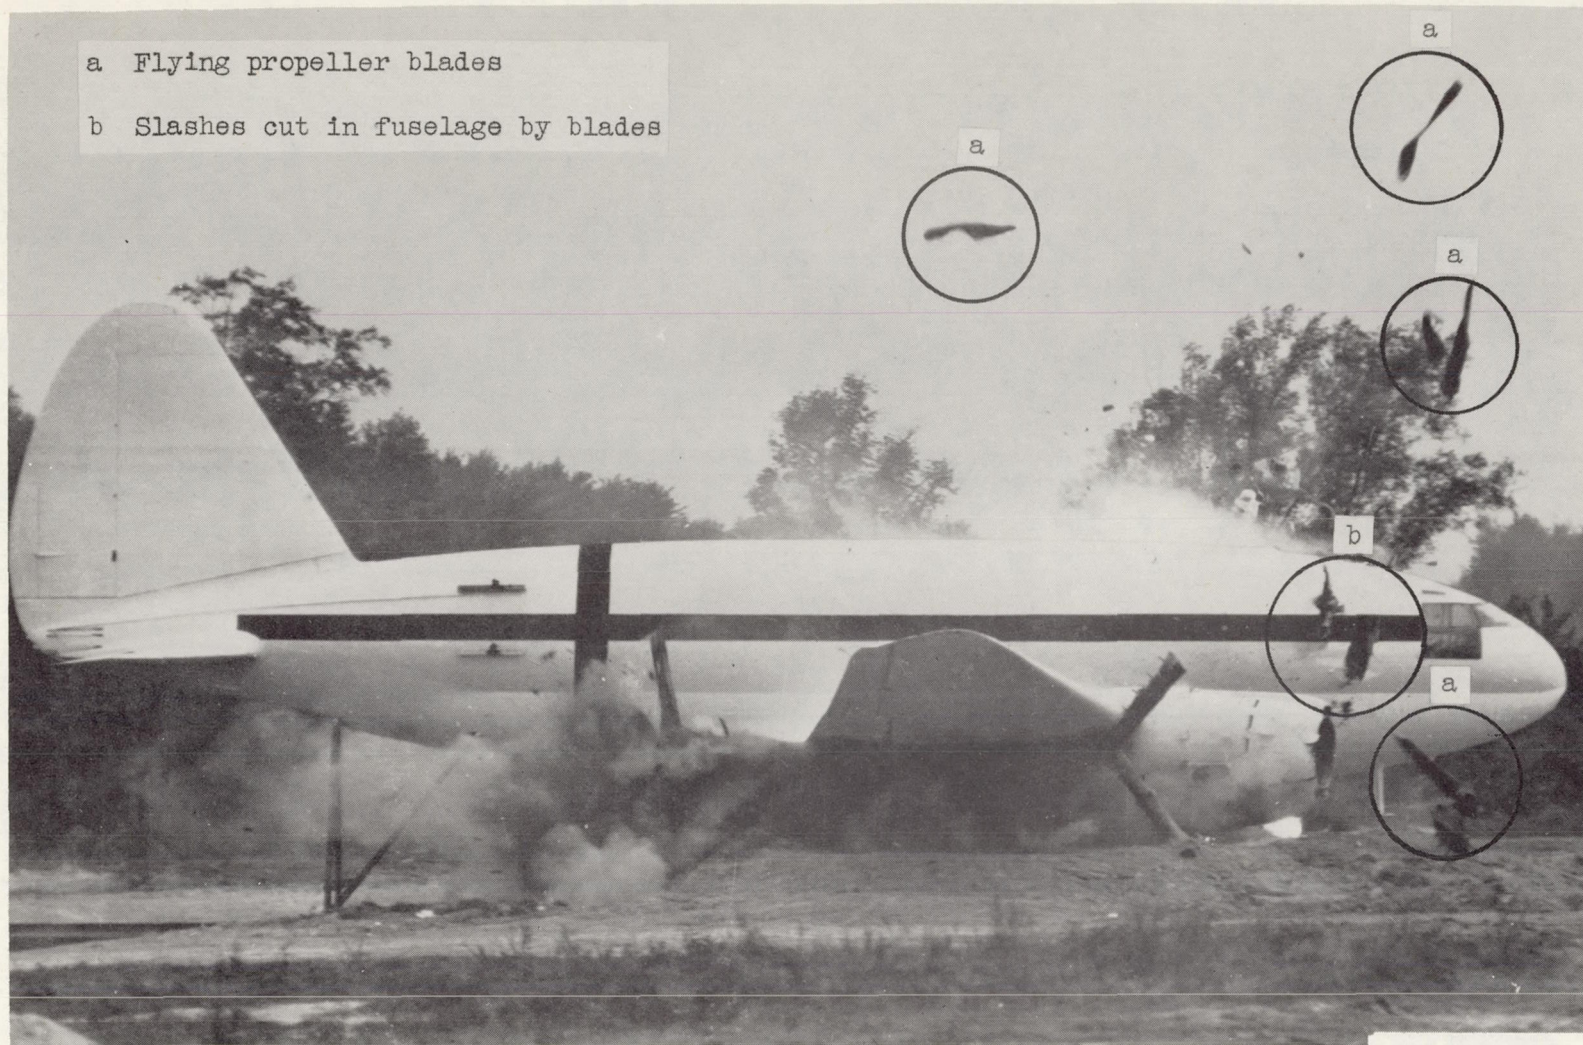
Figure 26. - Typical example of damage to fuselage by flying propeller blades.

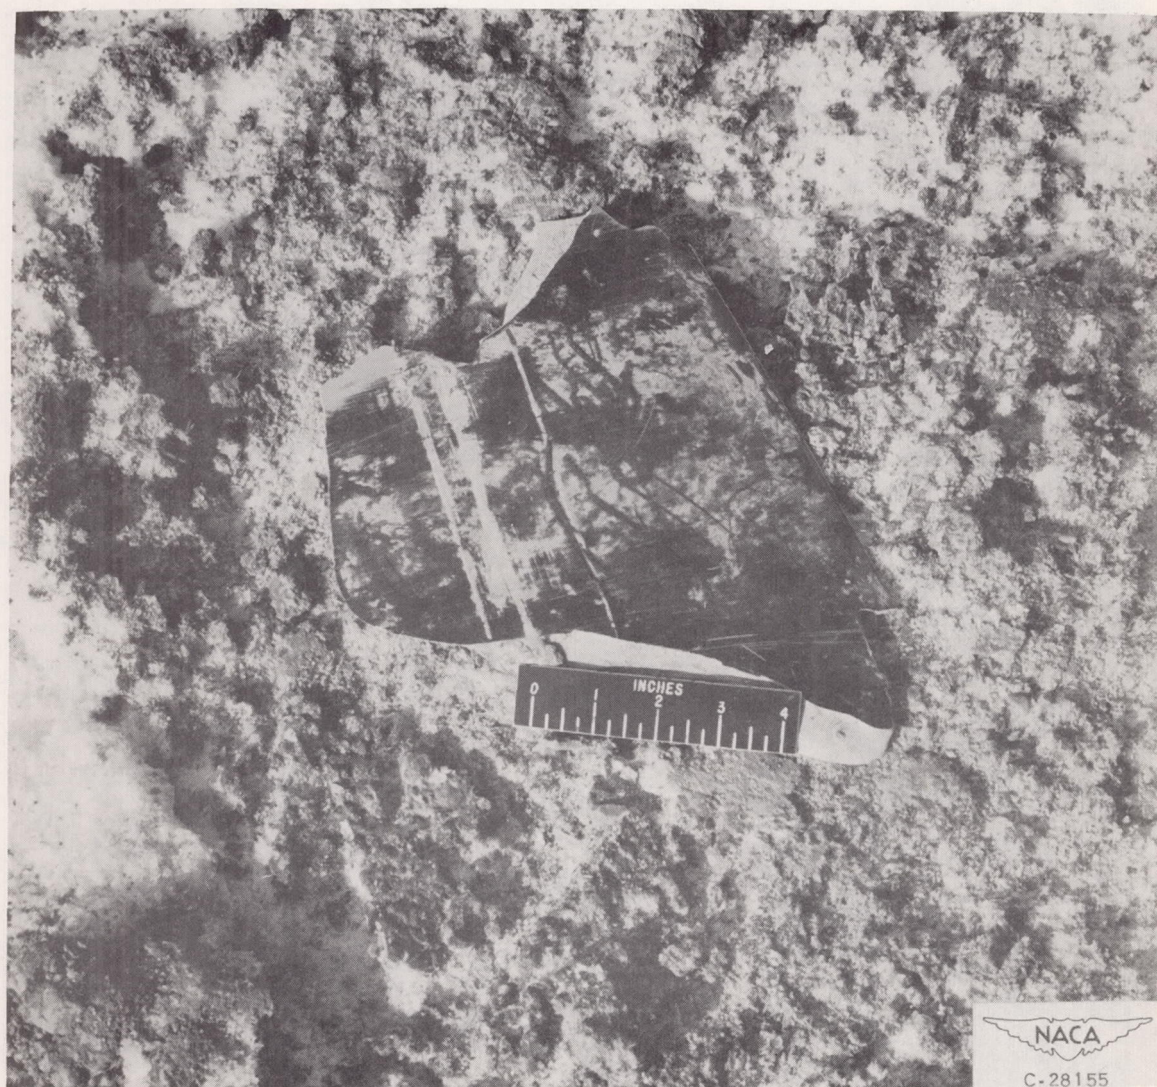
Figure 27. - Section of broken forged aluminum propeller blade caused by impact of blade with an obstacle.

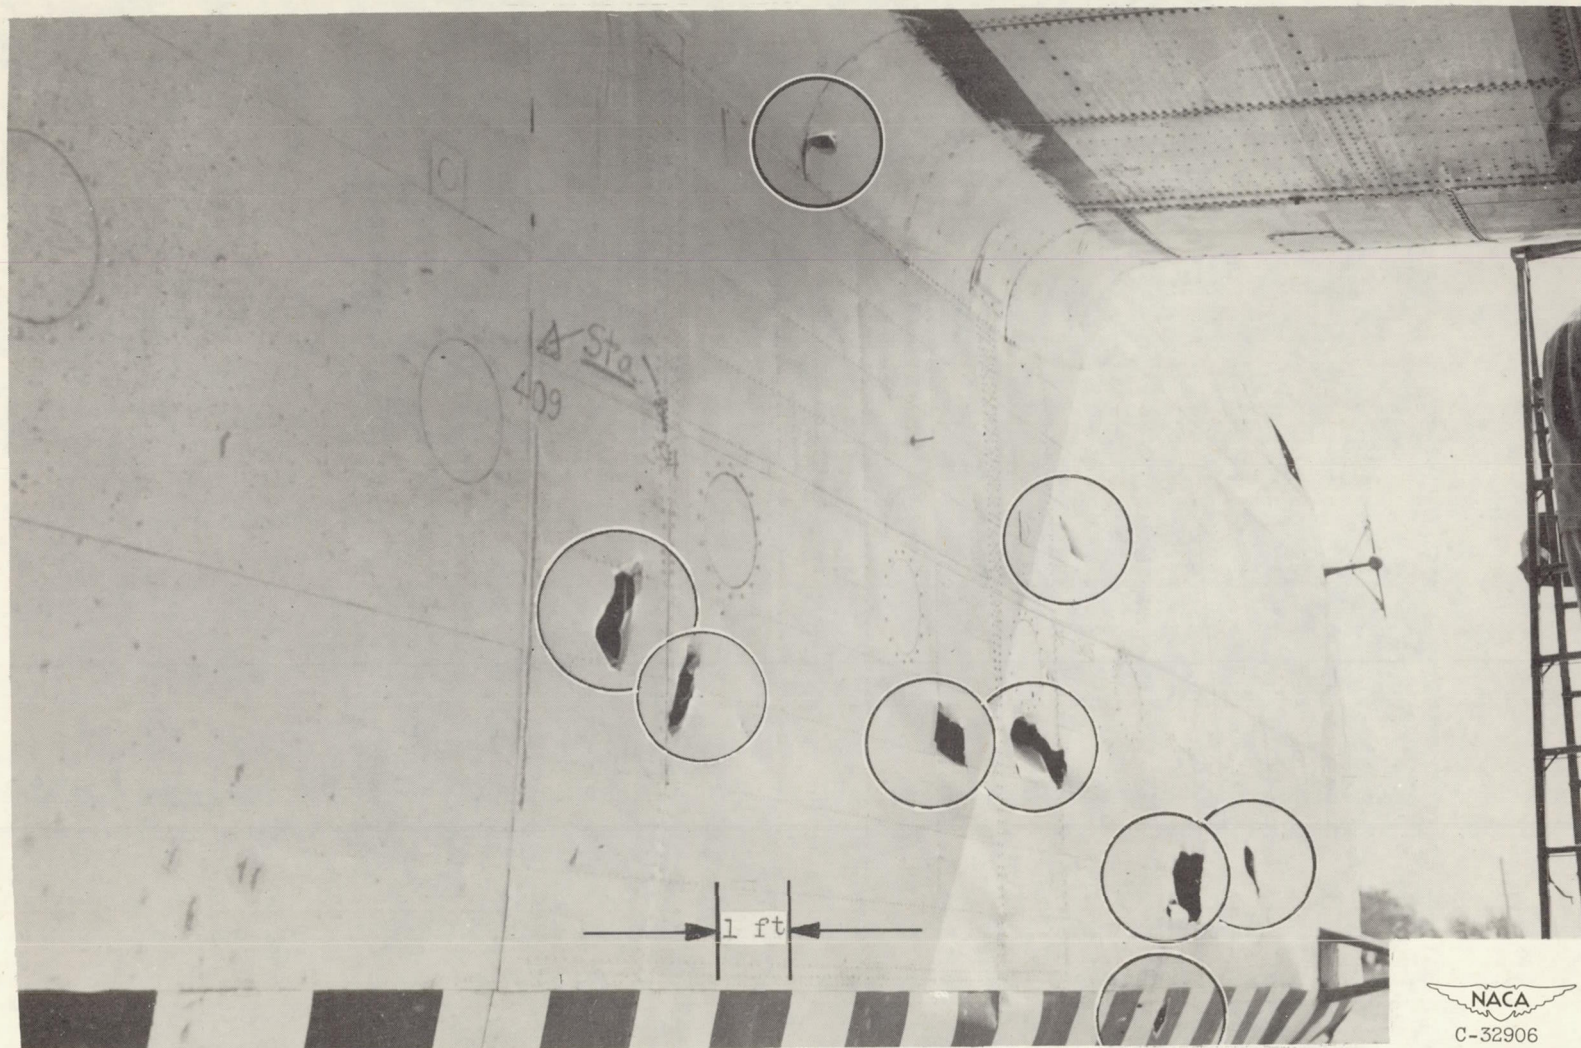
Figure 28. - Typical damage caused by flying fragments of forged aluminum propeller blades.

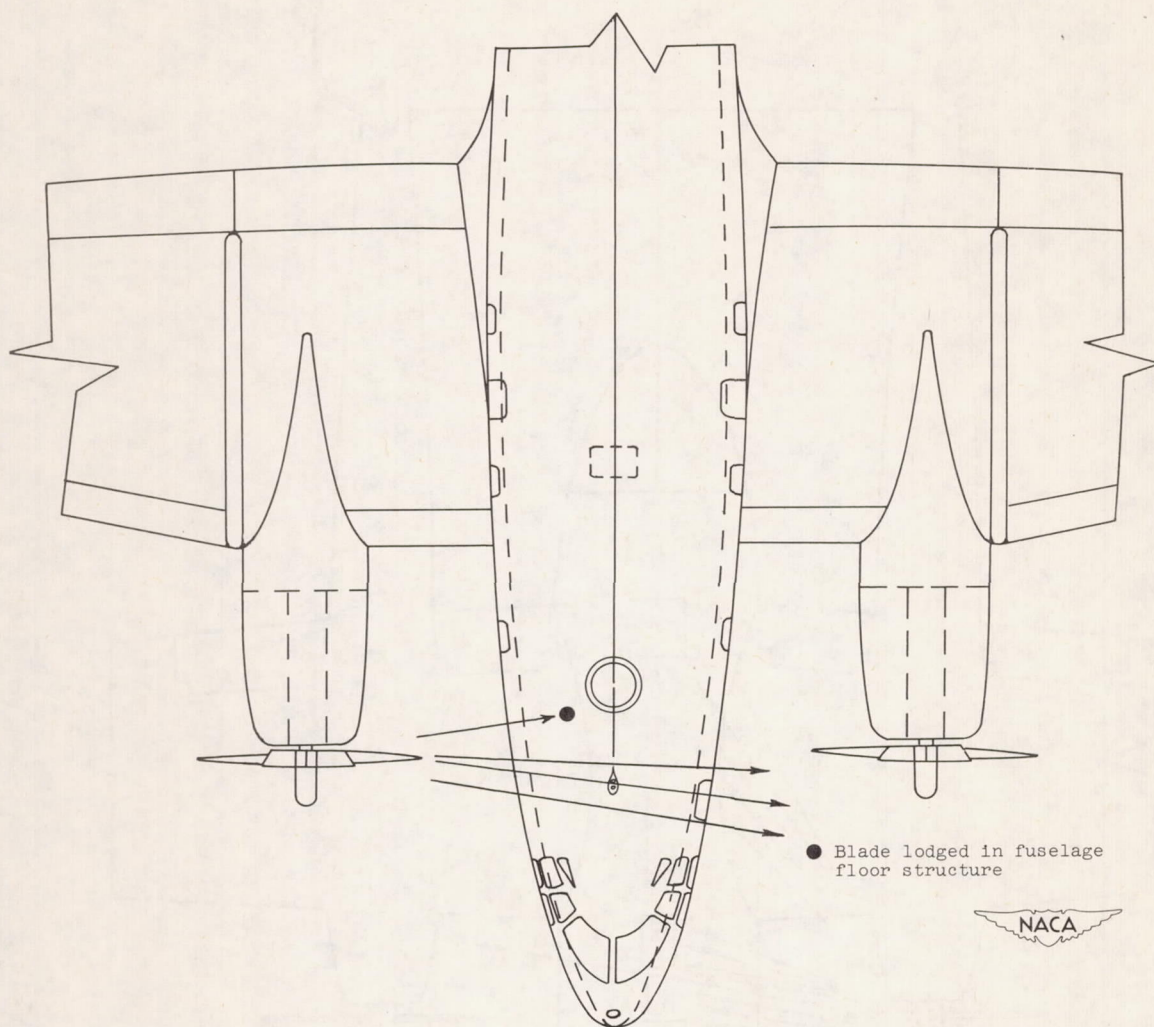
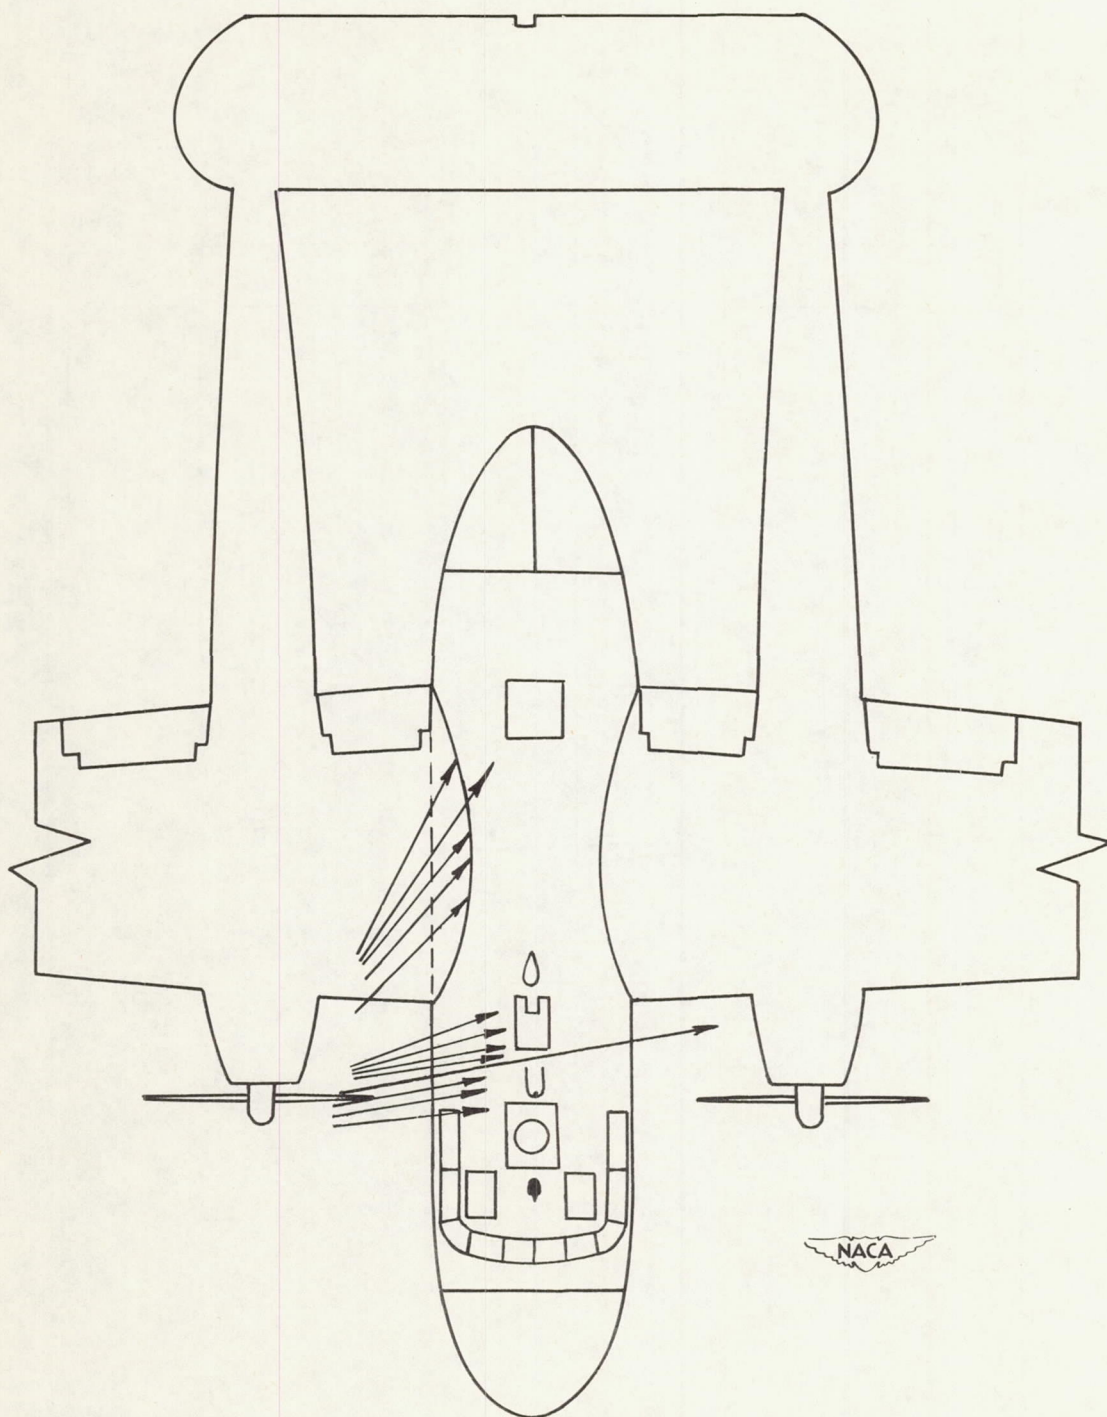
(a) Penetration by steel propeller blades during four crashes.

Figure 29. - Penetration of fuselage by propeller fragments.

(b) Penetration by forged aluminum propeller fragments during 14 crashes.
